BUILDING ENGINEERING REPORT (BER)

Building Name: Federal Building - 517 Gold Avenue SW
Building No: NM0024ZZ
Location: Albuquerque, New Mexico

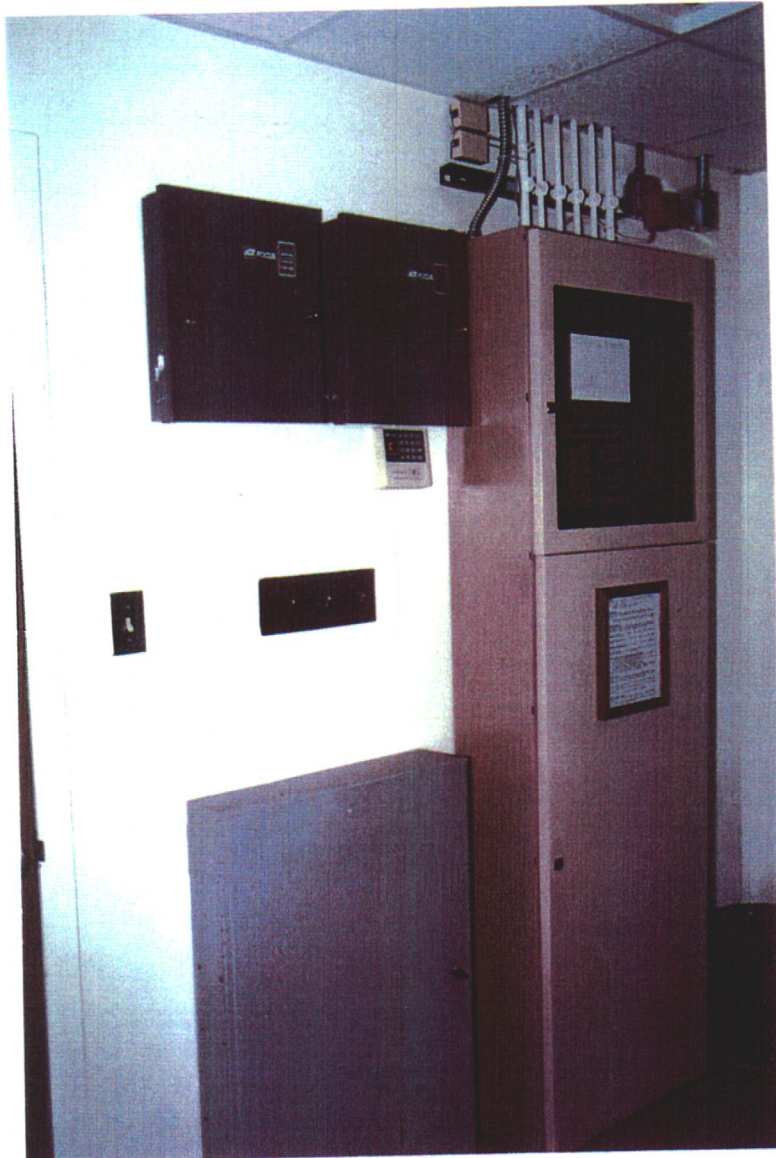
The building's entire Fire Alarm System was replaced in about 1992, with an Edwards Model 8500 system. However, an emergency voice evacuation system was not included as part of this life safety upgrade.

The building qualifies as a high-rise structure and an emergency voice evacuation system is recommended by the life safety code.

Edwards 8500 Main Fire Alarm Control Panel

It is recommended that an emergency voice evacuation system be added to the existing fire alarm system. The existing fire alarm horns can be utilized for the necessary speakers and the existing Fire Alarm Control Panel upgraded to include a voice evacuation system.

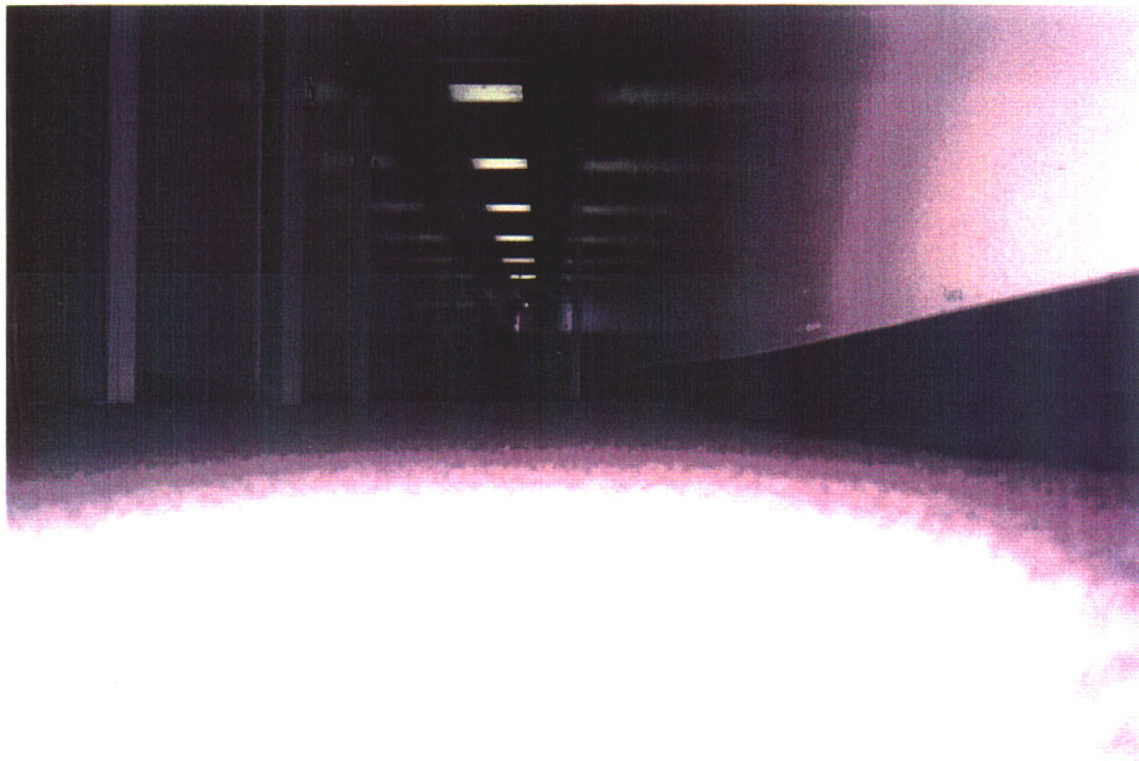
Throughout the building there exists no seismic or lateral bracing for any of the HVAC ductwork, fire protection piping, interior plaster and masonry partitions, lights or lay-in ceiling. The Uniform Building Code requires all non-structural equipment, piping, partitions and ceilings to be anchored to the primary seismic resisting system. In addition equipment and life safety systems must be restrained in such a manner as to remain functional following a major earthquake. Life safety systems would include the fire protection piping and the emergency lights.

View of Typical Corridor Floor

This work item is required only where the existing systems are left in place. Any new work associated with the replacement of piping, HVAC, lights and ceilings include the cost of seismic bracing in the installation. Work items include the removal of the existing plaster ceiling located above the lay-in ceiling. This work will include installation of lateral ties from the HVAC and piping to the underside of the structural slab using channel struts or rods. Partitions should have lateral braces located along the top of the wall and extend at 45 degrees to the underside of the structural slab.

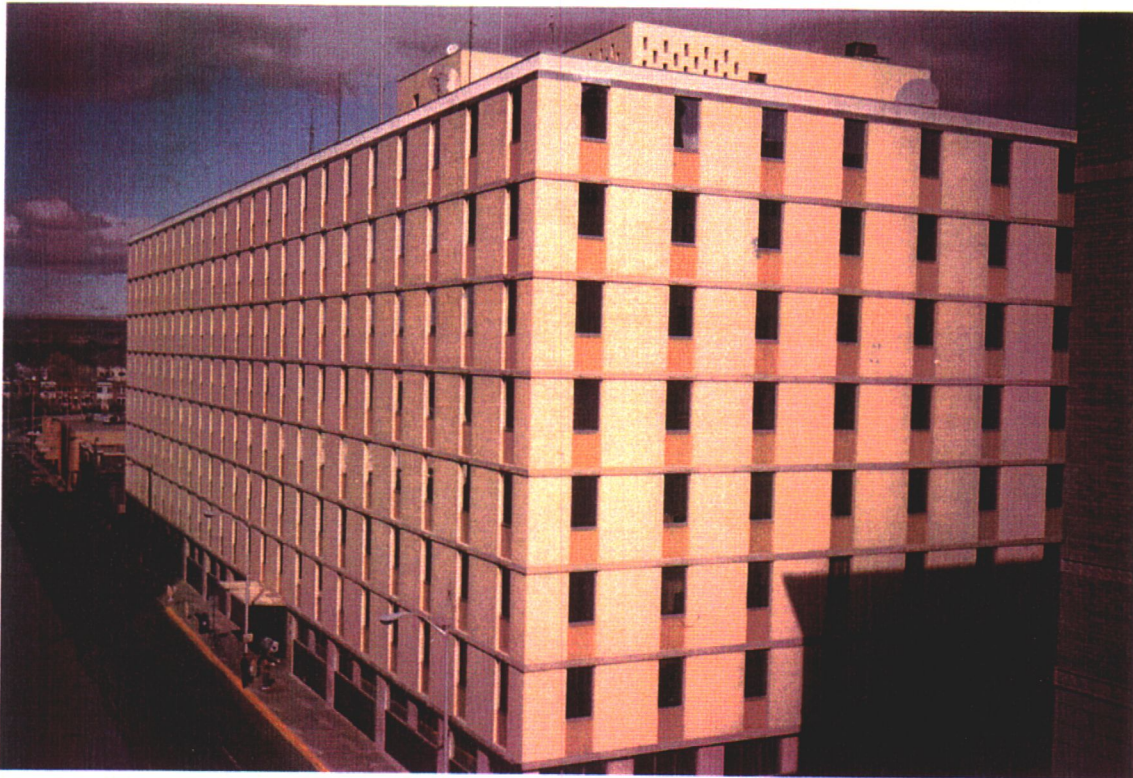
The unreinforced exterior masonry walls are not supported laterally to the seismic resisting system or to the building structure. The exterior masonry walls have no positive attachment to the building structure. In the event of an earthquake, the possibility of the wall collapsing is extremely likely.

The current attachment of the exterior walls do not comply with the Uniform Building Code minimum seismic requirements for non-structural elements. The life safety of building occupants as well as the public, such as pedestrians, is at risk.

View of Southeast Exterior

The attachment of the exterior walls would entail removing the plaster wall which houses an exterior heating convector. After removal of the interior plaster wall, a continuous plate along the exterior to sandwich the upper and lower portions of the wall in order for the wall to transfer lateral forces to the exterior spandrel beams and floor slab. The work will also involve architectural treatment and weather protection of the exterior wall attachment. However this would not upgrade the building appearance.
